STATE OF MISSOURI
DEPARTMENT OF NATURAL RESOURCES
DIVISION OF ENVIRONMENTAL QUALITY

Re: Harold Peck's 66
1211 W. Sunshine

CITY OF SPRINGFIELD
INTER-OFFICE MEMORANDUM

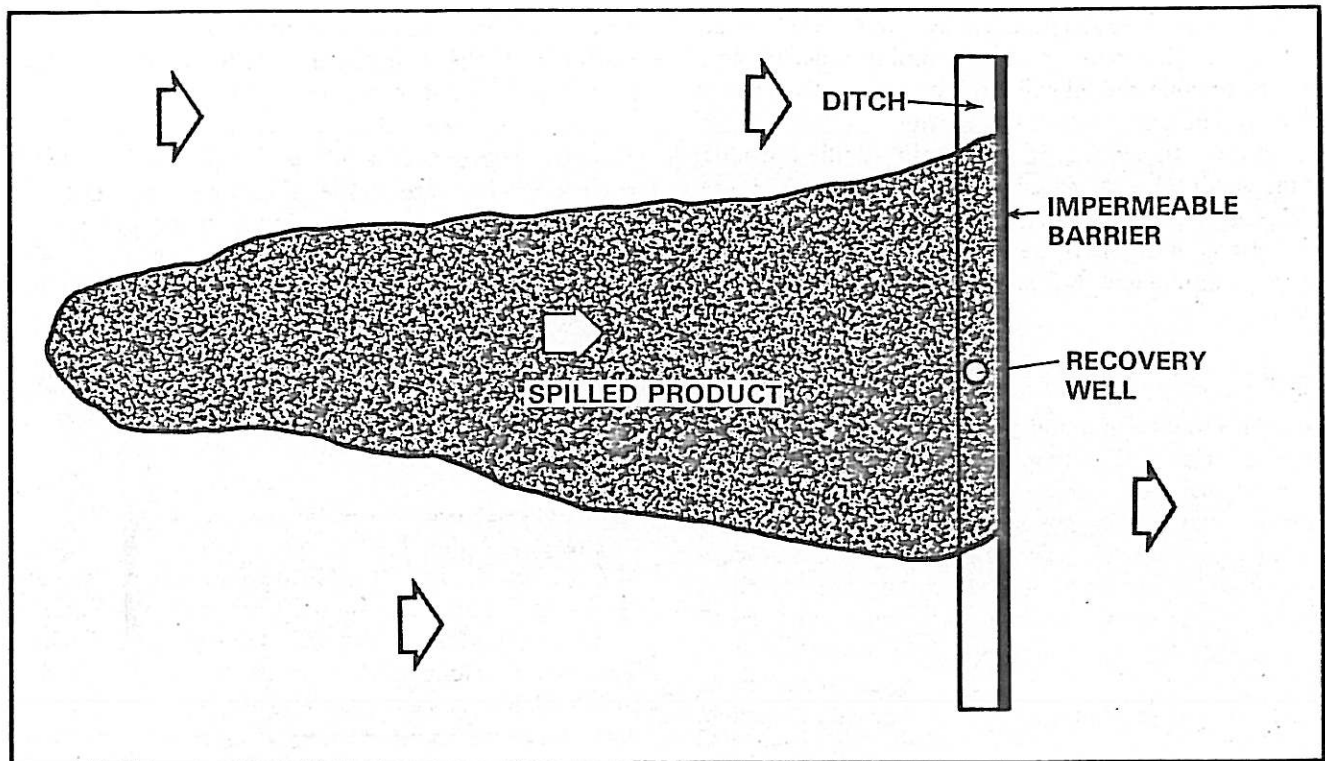
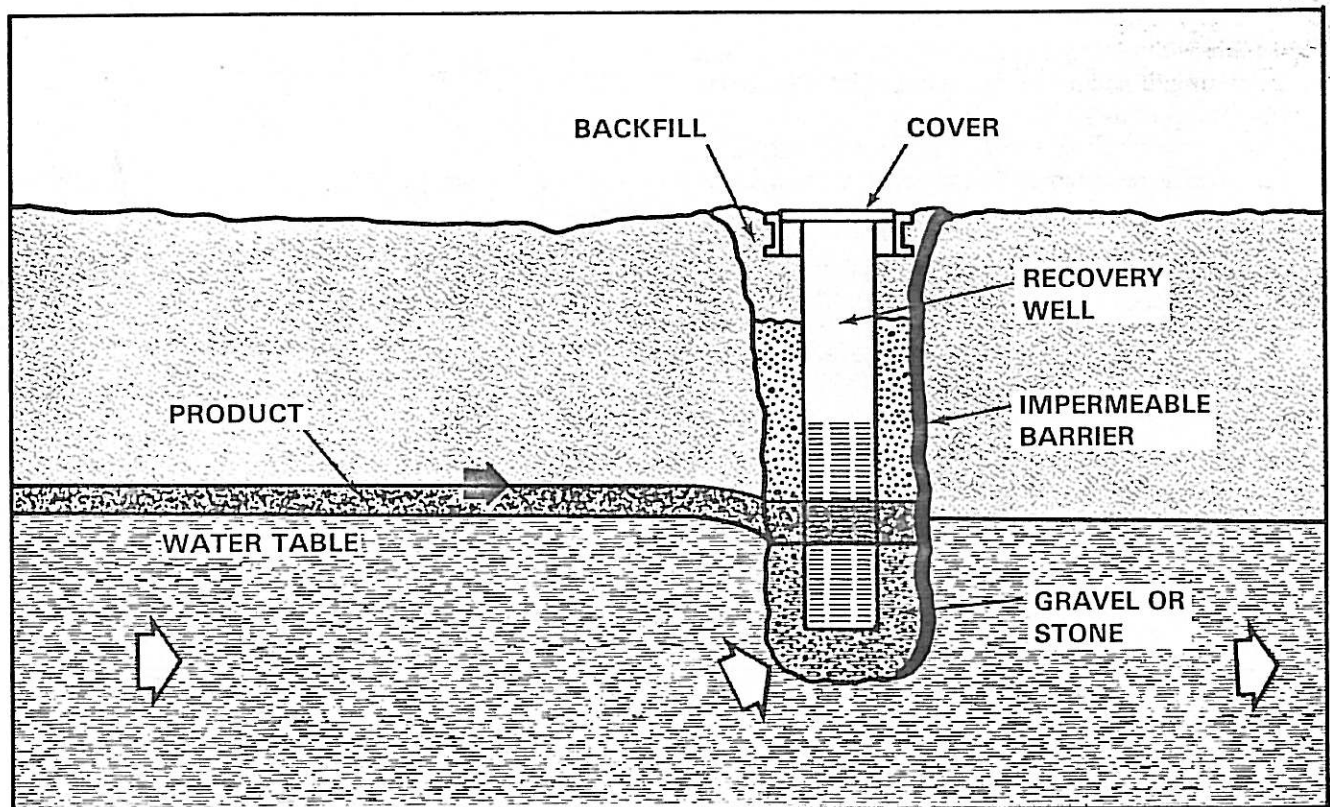
Figure 12 — Interceptor Trench

Trench-type recovery systems are generally limited to depths of six to 10 feet. Depths greater than these may be impractical due to soil conditions, the capabilities of normally available excavating equipment and the large amount of soil which must be removed.

A ditch should be constructed across the entire front of the migrating body of oil. If product has entered a confined structure such as a building or sewer, the trench should be dug as close as possible to the structure without damaging its basement or foundation.

If soil conditions will permit, ditches should be kept as narrow as the bucket on the excavating equipment, and should be constructed to a depth of one to four feet below the water table surface. The downstream wall should be lined with an impermeable material such as polyethylene film (Figure 12) to block floating oil but permit water to pass below. The barrier material should be placed a minimum of a few feet above the product level and a minimum of one foot below the oil/water interface. If the ditch will be used as a withdrawal point to lower the water table, the barrier must be situated deep enough to intercept the product at the lowest drawdown level. As it usually is advisable to fill the ditch with coarse material, such as crushed stone or gravel, the film must be of sufficient strength to prevent puncture or tearing.

One or more randomly slotted culvert pipes, or similar material wrapped with plastic window screening, should be lowered to the bottom of the trench. The bottom of the culvert should be capped to prevent silt build-up. Once the culvert is in place, the ditch should carefully be filled to within two feet of the native ground surface with a very porous material, such as crushed stone or gravel. Soil should then be used to fill the remainder of the trench.
